**DEPARTMENT OF TRANSPORTATION****DIVISION OF ENGINEERING SERVICES**

Contract #: 04-0120F4Cty: SF/ALA Rte: 80 PM: 13.2/13.9File #: 1x.28**WELDING INSPECTION REPORT****Resident Engineer:** Casey, William**Address:** 333 Burma Road**City:** Oakland, CA 94607**Report No:** WIR-026565**Date Inspected:** 25-Oct-2011**Project Name:** SAS Superstructure**OSM Arrival Time:** 700**Prime Contractor:** American Bridge/Fluor Enterprises, a JV**OSM Departure Time:** 1530**Contractor:** American Bridge/Fluor Enterprises, a JV**Location:** Job Site**CWI Name:** Salvador Merino**CWI Present:** Yes No**Inspected CWI report:** Yes No N/A**Rod Oven in Use:** Yes No N/A**Electrode to specification:** Yes No N/A**Weld Procedures Followed:** Yes No N/A**Qualified Welders:** Yes No N/A**Verified Joint Fit-up:** Yes No N/A**Approved Drawings:** Yes No N/A**Approved WPS:** Yes No N/A**Delayed / Cancelled:** Yes No N/A**Bridge No:** 34-0006**Component:** SAS OBG**Summary of Items Observed:**

This Quality Assurance Inspector (QAI) was present at the SAS OBG segment 14W located at Pier 7. The following items were observed.

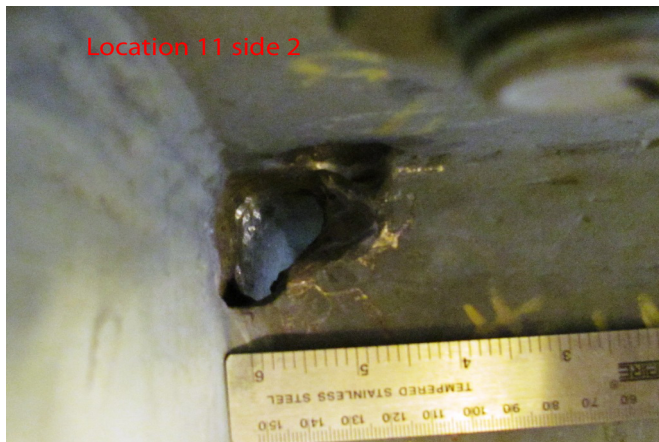
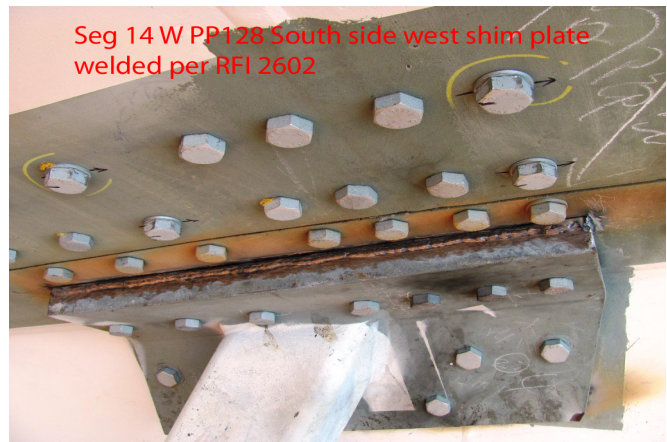
Location 3; Hole has penetrated into an existing weld access hole on the shear plate but part of shear plate remains. The rat hole has a radius that is not consistent through the shear plate in accordance with AWS D1.5 paragraph 3.2.5 requirements. Bolt has not been installed.

Location 11; Hole has penetrated into an existing weld access hole on the shear plate. A rat hole with a radius that is not consistent through the shear plate in accordance with AWS D1.5 paragraph 3.2.5 requirements. Bolt has not been installed.
